Nulex[®] is NOT Corrosive

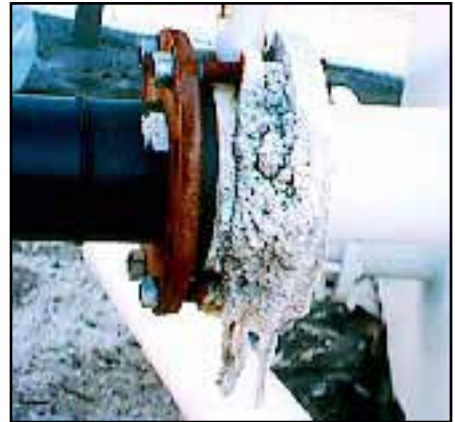
From time-to-time Nulex customers comment, “the fittings on our Nulex tanks are corroding.” What appears to be corrosion, is really only fertilizer crystals. Nulex is NOT corrosive. But because Nulex is thinner than water, it can escape through “microscopic-sized” weep holes. Since the hole and the amount of liquid escaping is so small, no dripping or puddling occurs, making the leak undetectable. As the Nulex slowly escapes, liquid exposed to the air evaporates and the remaining solids crystallize. It is a long, slow process that can give the appearance of corrosion. To clean these crystals from fittings, use a weak aqua ammonia solution and a wire brush. Underneath you’ll find fresh, clean metal.

What appears to be corroding metal on Nulex tanks, is really only fertilizer crystals.
